POLE  
P613502

APPROVED  
21 Dec 2021

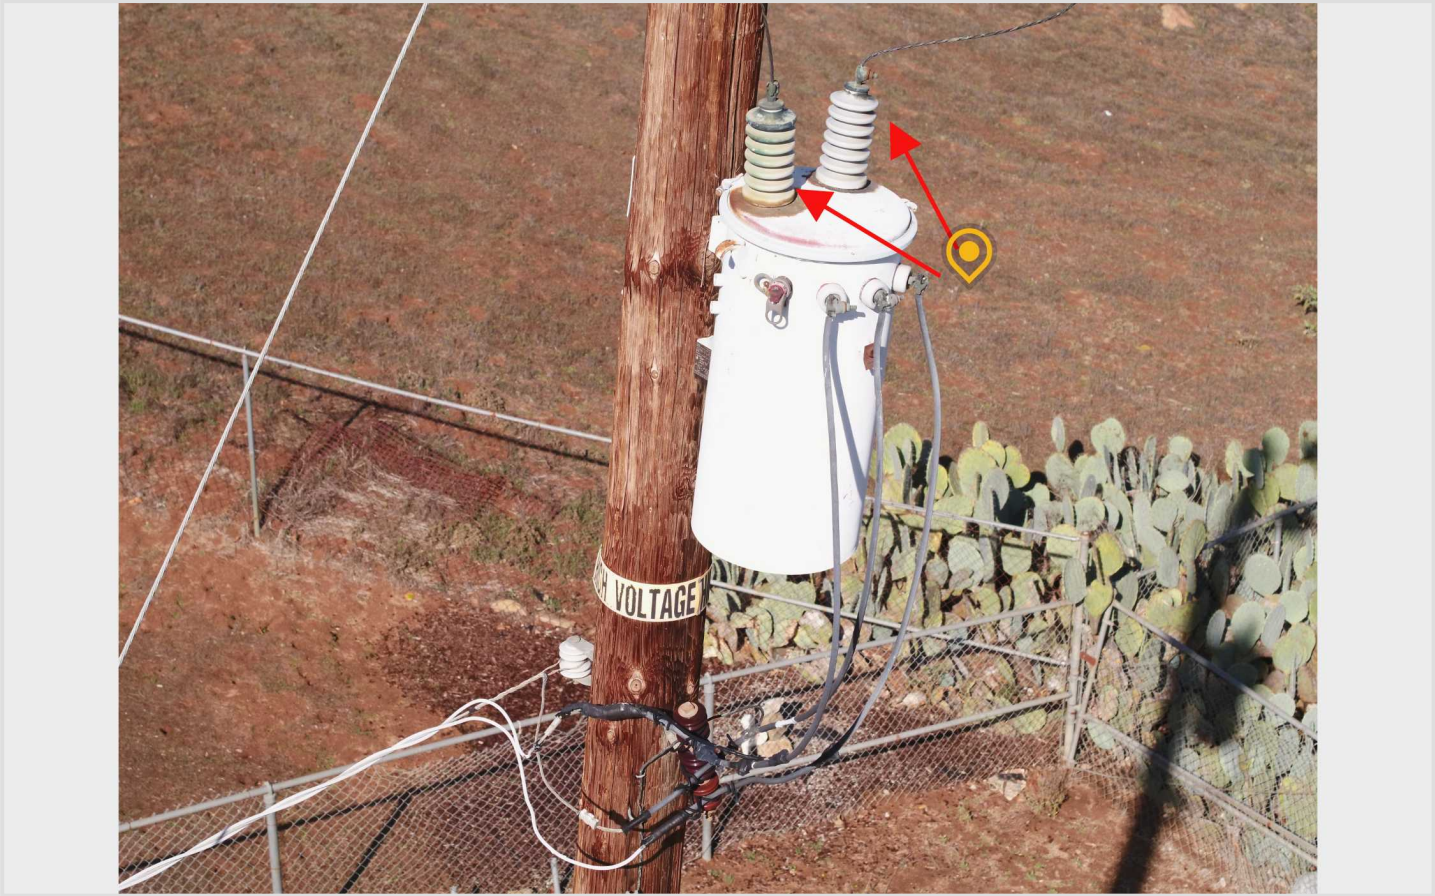
235 Damaged Arrestor/Insulator/Dead-End

Damaged transformer bushings

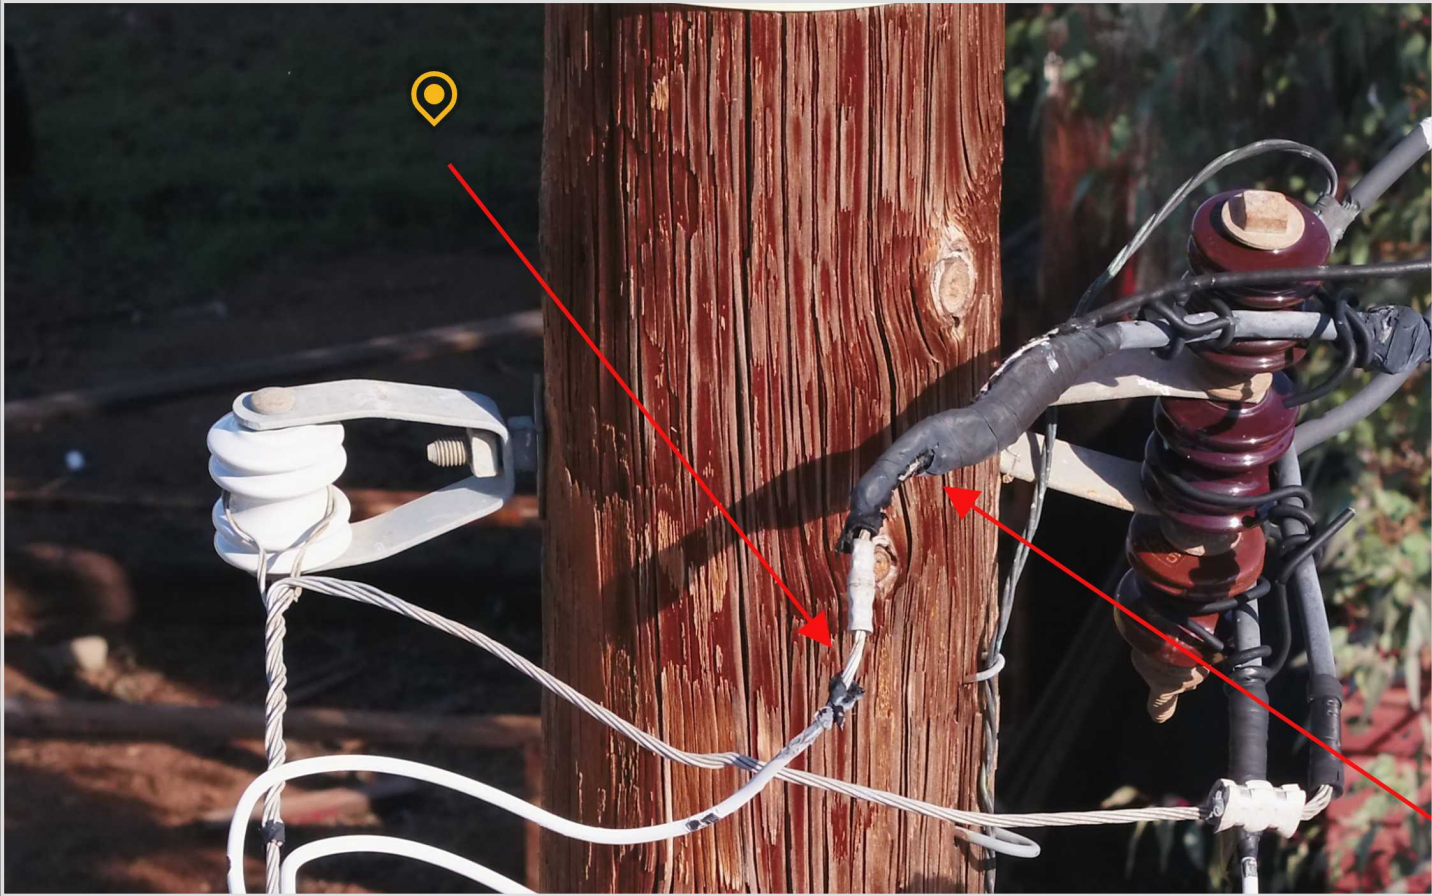
264 Bare or Wrapped Service

Uncovered connection and insulation on wire has melted

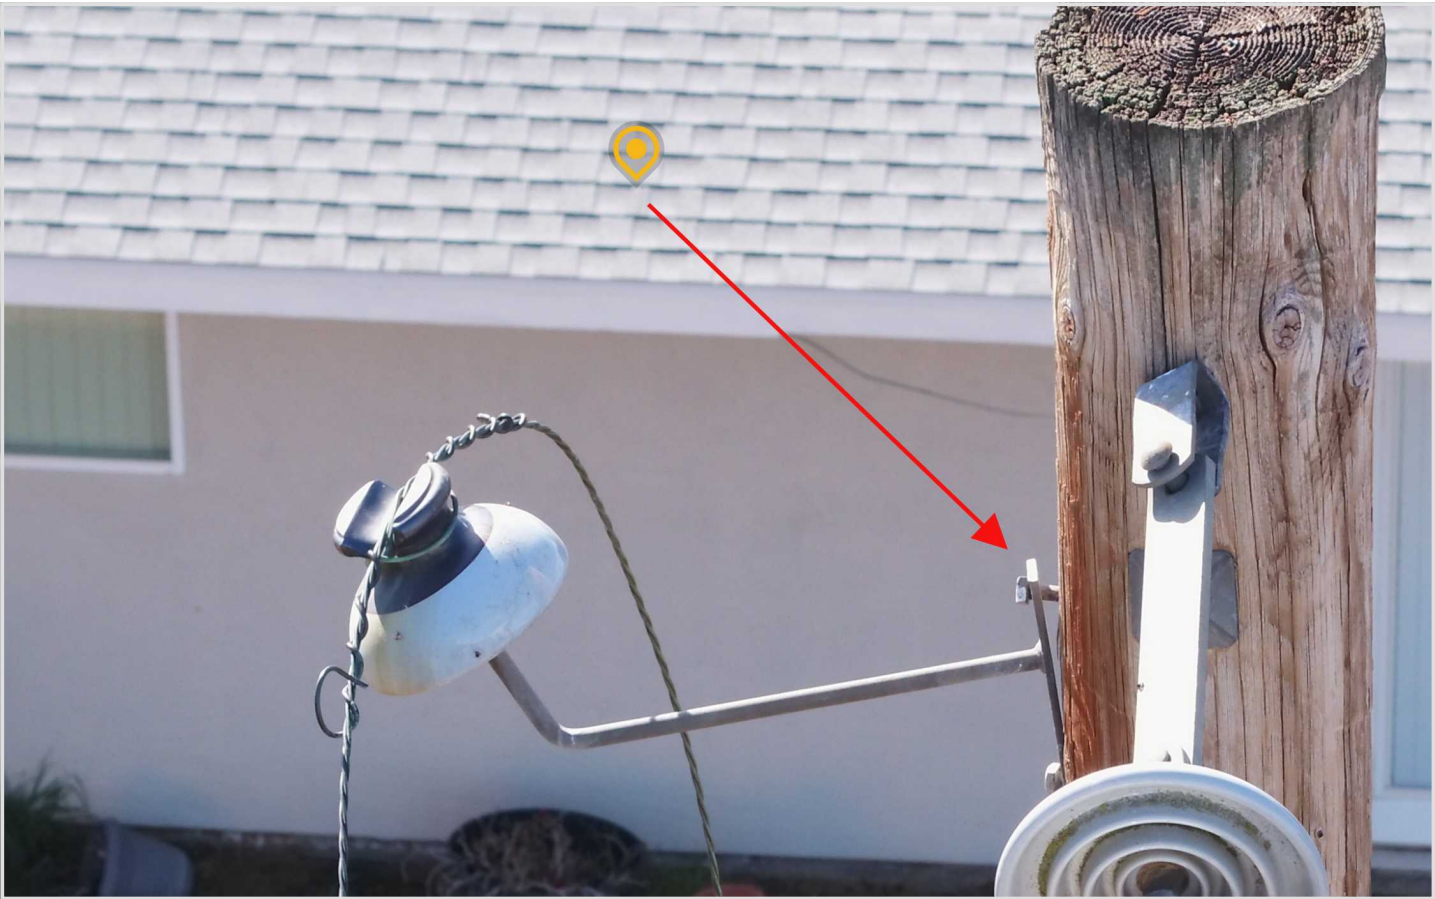
206 Damaged/Missing Pole Hardware

Loose lag
